QA-244
Ozmon House
Centreville Landing
Private

circa 1870-85

INVENTORY FORM FOR STATE HISTORIC SITES SURVEY

Captain Ozmon House

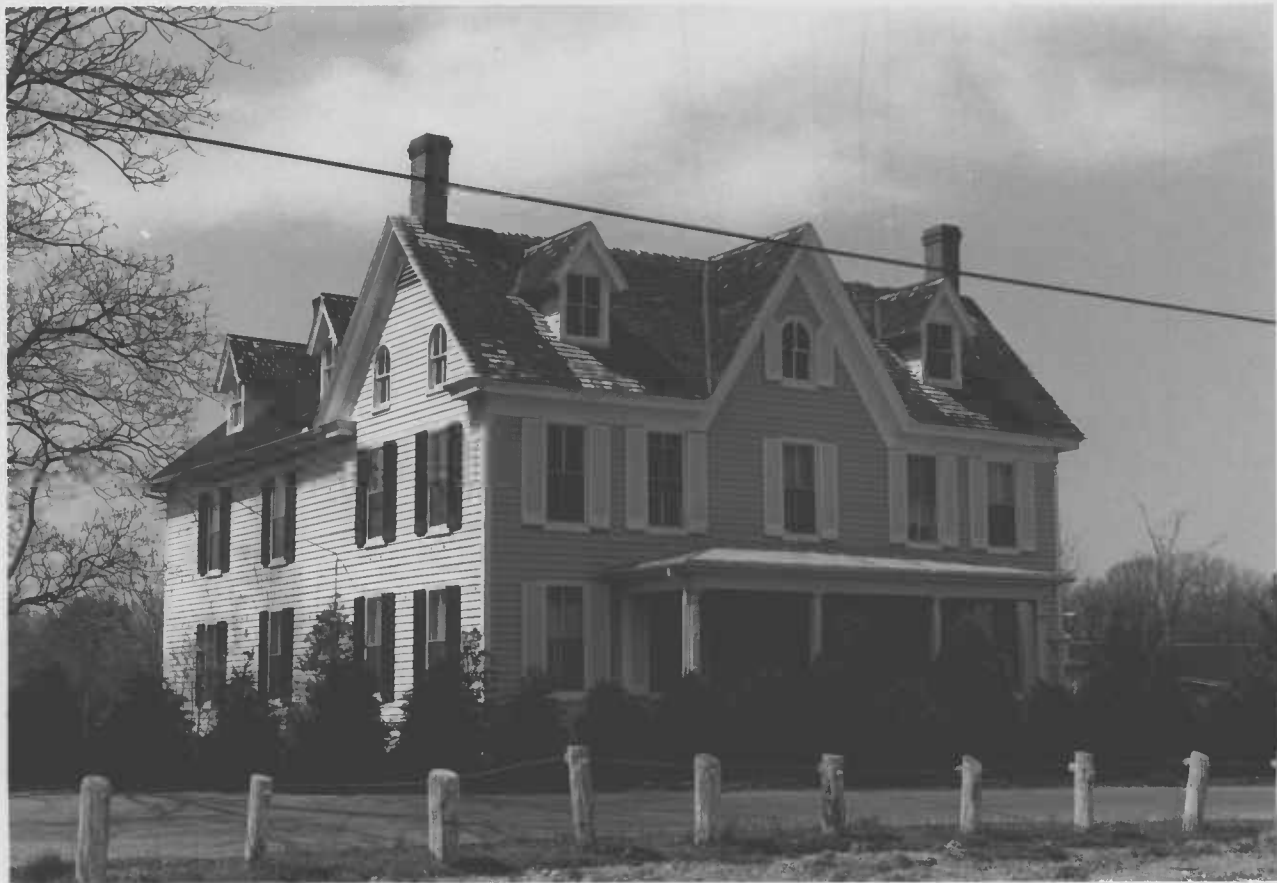
QA-244

Captain Ozmon House
Centreville Wharf
Centreville, Maryland
Orlando Ridout V 1980
Front facade from NE

The principal facade of the house faces east, toward the road. The door is located in the center bay on the first floor, flanked by two 2/2 windows on each side. There are five 2/2 windows on the second floor. A steeply pitched cross gable with a single segmental sash 2/2 window is centered on this facade. Further emphasis on the center bay is reflected in the spacing of the fenestration and in the entrance door, which is framed with sidelights and a three-light transom. A one story open porch with chamfered posts covers the center three bays on the first floor. The house rests on a continuous brick foundation and is covered with plain horizontal weatherboards, beaded cornerboards, and a wood shingle roof. The eaves are boxed in and finished with a wide frieze board below a deep soffit trimmed with a complex crown mold and bed mold. Single pitched roof 2/2 dormer windows flank the center cross gable.

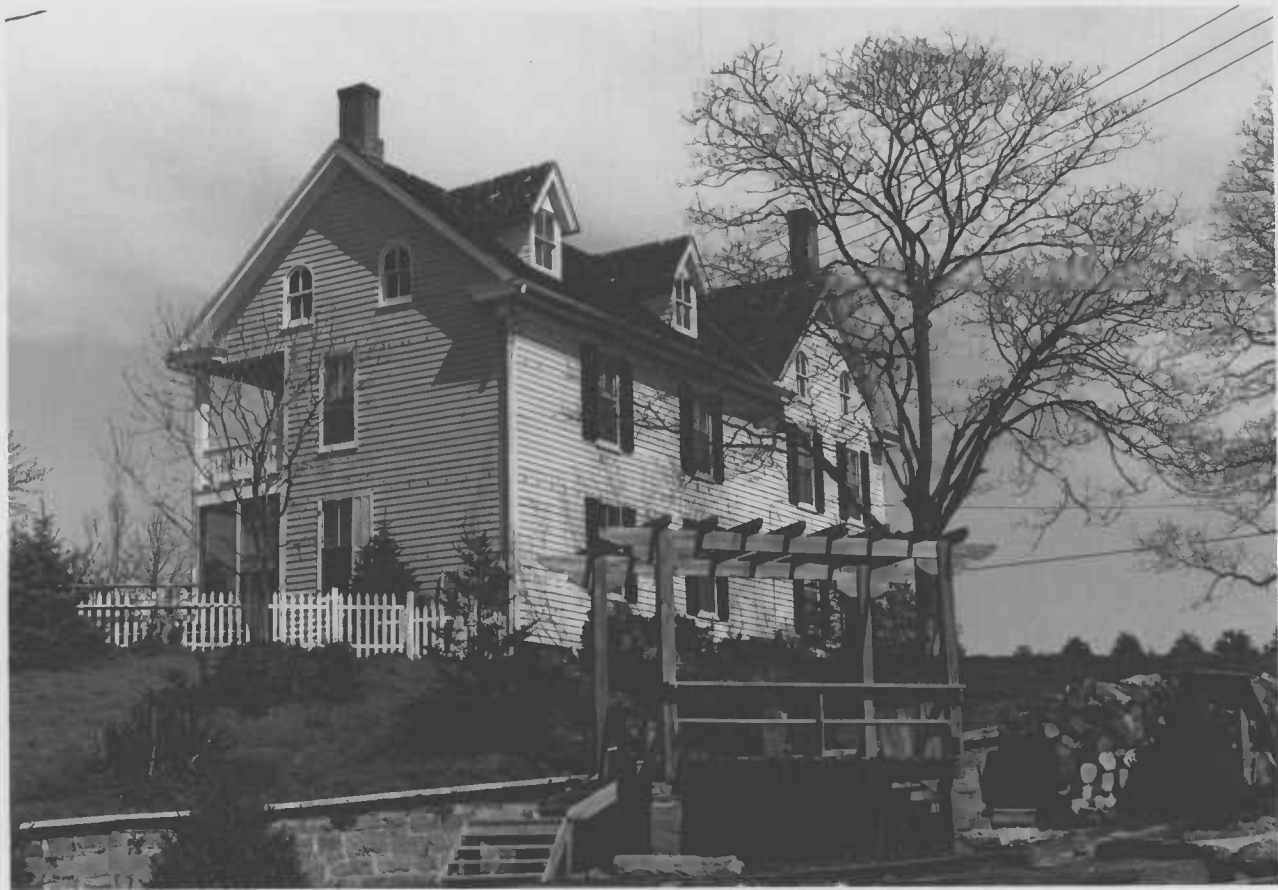
QA-244

Captain Ozmon House
Centreville Wharf
Centreville, Maryland
Orlando Ridout V 1980
Rear view from SW

The south two bays of the rear facade is covered by the rear L. There is a door in the center bay and two 2/2 windows to the left on the first floor and three 2/2 windows on the second floor. One 2/2 pitched roof dormer pierces the roof on the third floor. The two story porch extends across the entire rear facade as well as the north wall of the rear L. It has chamfered posts and a simple railing with scrolled band-saw ballusters.

The north wall of the L has asymmetrical fenestration. On the first floor, there are two doors in the center flanked by single 2/2 windows to each side. There are doors in the east and center bay on the second floor, opening onto the porch, and a single 2/2 window to the west. Three 2/2 pitched roof dormers are ranged across the roof. As previously
